Neutral Citation Number: [2025] UKUT 053 (LC)

IN THE UPPER TRIBUNAL (LANDS CHAMBER)
IN THE MATTER OF A NOTICE OF REFERENCE

COMPENSATION – TREE PRESERVATION ORDER – cracks to rear of property – refusal of consent to fell an oak tree in adjoining land – claim for costs of underpinning works – causation – claim dismissed - Town and Country Planning (Tree Preservation) (England) Regulations 2012

**98 Old Park Ridings,
Enfield,
London, N21 2EP**

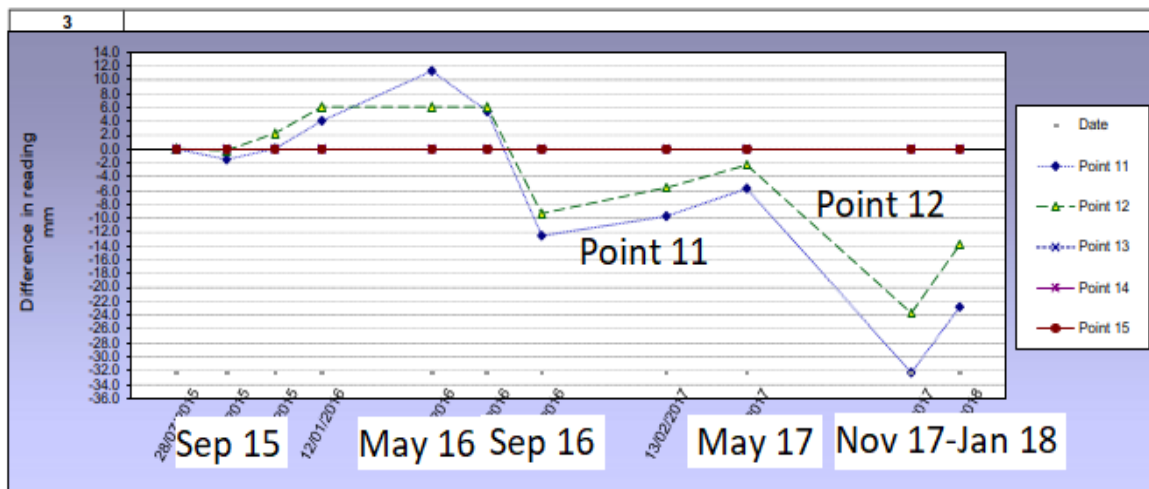
44. The positions of level monitors and the maximum reading at each are summarised in the relative movement sketch below. The first number is the point number and the second number is the greatest level difference in mm recorded at that point over the period. Two points are missing: point 4, which is close to point 3 and showed very similar readings, and point 9, which is close to point 8 and showed very similar readings. Visually it is apparent that the greatest movement was to the rear of the garage at points 10 (-27mm), 11 (-32mm) and 12 (-24 mm). The only significant movement on the extension is shown at point 6 (-21mm). It will be noted that point 6 is the corner of the extension where the TPBH1 investigations were made.

46. The engineering experts agreed that the monitoring at points 10, 11 and 12 around the garage displayed a seasonal pattern of movement indicative of tree root desiccation of a shrinkable clay subsoil below the foundations, but Mr Freeman considered that this could have been caused by any of the trees at the rear of the property, including the cypress tree and privet hedge growing close to the garage. There was obvious progressive downward movement recorded at points 6, 10, 11 and 12 and Mr Freeman considered that the soil at the rear had been affected by sub-surface erosion. The moisture contents recorded in BH1 at depths of 0.9m and 1.5m were unnaturally high and indicative of a soil that had undergone swelling and softening, which can only occur where a void is created by excavation or erosion. The presence of the soft layer was confirmed by the suction tests and the exceptionally low shear vane reading of 39kPa at 0.9m. In his view the only plausible explanation for the progressive downward movement was sub-surface erosion caused by water escaping from the leaking drainage and running down the slope under the foundations to the extension and the garage. Softened soil was a symptom and it was compression of the voids that would cause downward movement to the supported foundations. Drainage repair in autumn 2015 may have encouraged erosion by lowering the water table, allowing a higher flow of water through the soil in the summer. No investigation was made in June 2015 of the downpipe and drains at the rear of the garage to rule out leakage there too.
