Neutral Citation Number: [2025] UKUT 053 (LC)

IN THE UPPER TRIBUNAL (LANDS CHAMBER)
IN THE MATTER OF A NOTICE OF REFERENCE

COMPENSATION – TREE PRESERVATION ORDER – cracks to rear of property – refusal of consent to fell an oak tree in adjoining land – claim for costs of underpinning works – causation – claim dismissed - Town and Country Planning (Tree Preservation) (England) Regulations 2012

**98 Old Park Ridings,
Enfield,
London, N21 2EP**

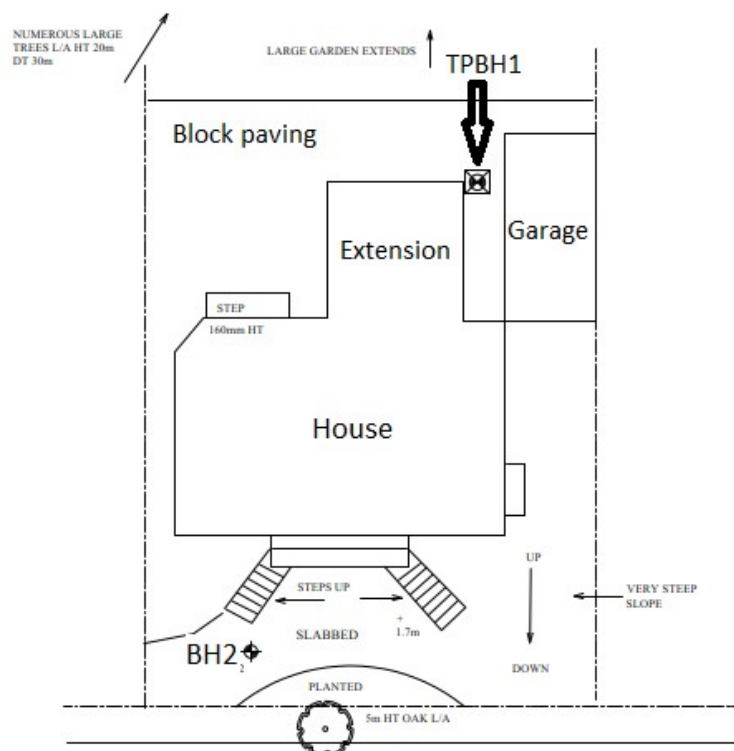
9. Crawford instructed CET Structures Ltd (“CET”) to carry out ground investigations. CET visited the property on 1 June 2015 and in the course of their investigations dug a trial pit and sank two boreholes. The block plan below is extracted from their site investigation factual report and shows the relationship of the house, the extension and the garage, together with the location of the trial pit and borehole 1 (TPBH1) on the rear right corner of the extension. As notes on the plan show, the site slopes down from rear to front and from left to right looking from the road frontage. Borehole 2 (BH2) was sunk at the front of the house as a control. The findings of the site investigation (“the CET report”) were supplied to Crawford, including an analysis of root samples dated 4 June 2015 and laboratory test results dated 10 June 2015.
