OUTER HOUSE, COURT OF SESSION

[2021] CSOH 77

OPINION OF LADY WOLFFE

The car park

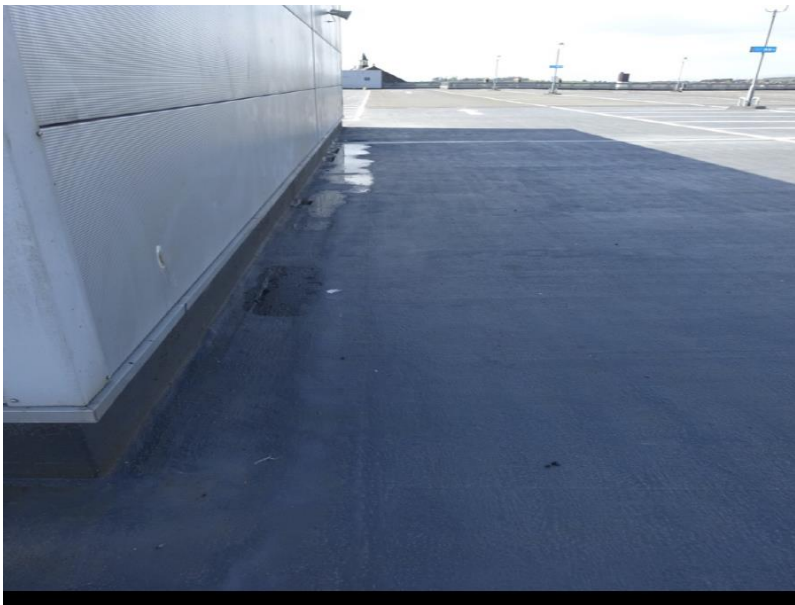
[86] In respect of ponding, as illustrated in the photo below, he accepted that the standing water in no way affected the operation of the car park.

edge of a built-structure (see para [86], above). In terms of the photographic evidence, the total area of ponding or damp patches was individually of very modest proportions, was very shallow and the overall area affected constituted only a very small proportion of level 3, a characterisation which Mr Clarkson accepted. He also accepted that, as depicted in the few photographs he had taken, all parking bays were usable and nothing would affect the reasonable operation of the car park.

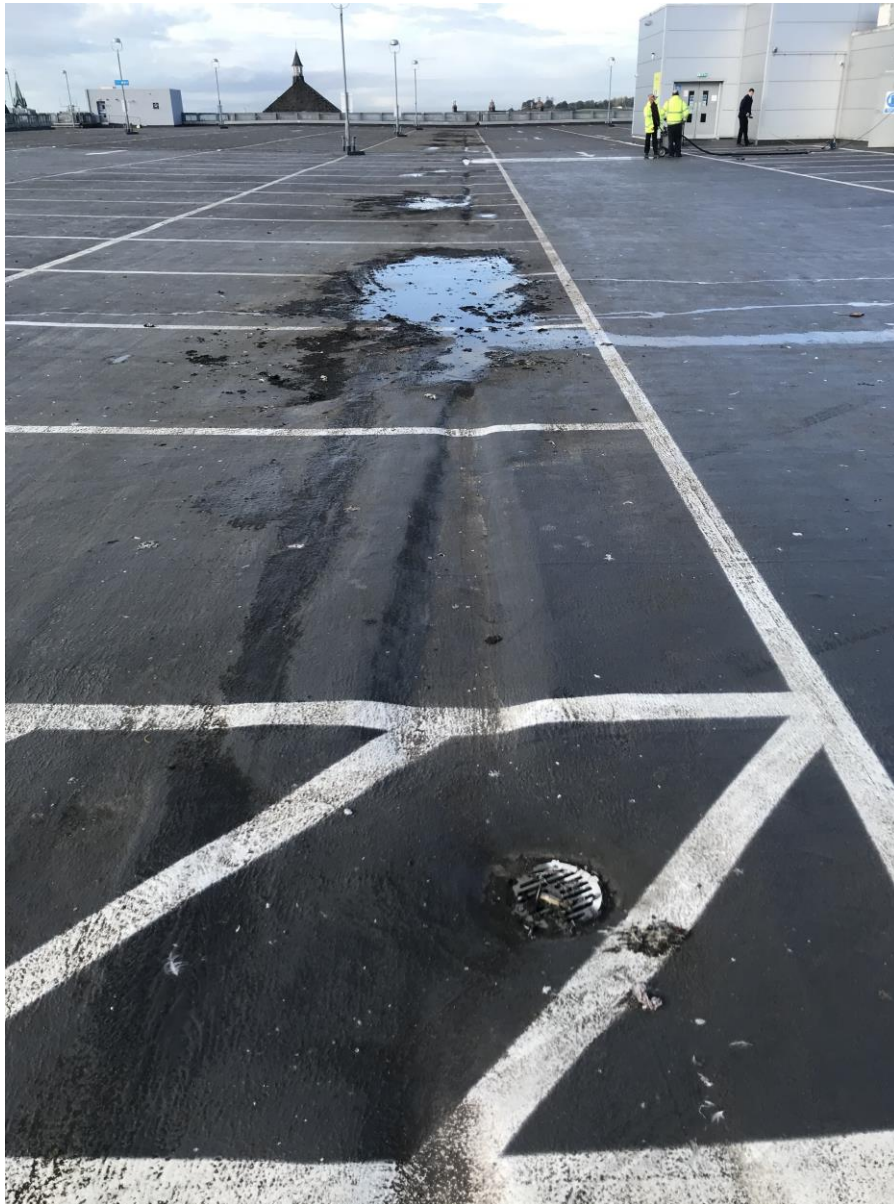
[140] Mr Clarkson relied on a levels survey he undertook in January 2021 (produced as appendix 4 to Clarkson 3) and three photographs he had taken of level 3 on a dry day. The latter showed small areas of damp (which had not yet evaporated) at points where the surface level of the deck was below that of the nearest drain. Below is the photo he reproduced with the levels survey:

[141] As depicted in the photographs, the largest of the ponds was estimated to be no more than about 1.5 by 0.700 metres. Their locations corresponded broadly with the line of the valley gully running on an east-west axis. Another area of ponding was adjacent to the

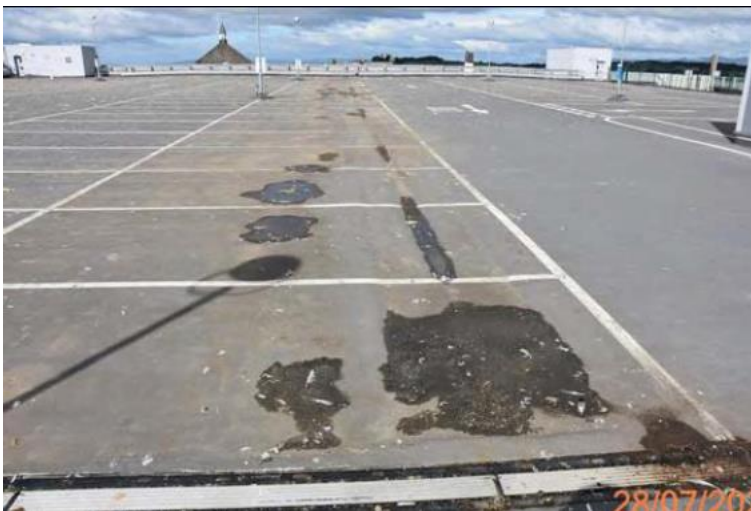
shedding of rainwater and followed good practice” (Robery 1 at paragraph 4.2.4). Mr Davis noted that while the car park was generally laid to a minimum fall (of 1 in 60), there were instances where the fall is less than as recommended. In each of his four reports he had also noted some ponding, but this was not uncommon in car parks and the ponding was not significant. The photographs Prof Robery took after his visits to the car park were appended to his reports. He noted that he found that the surface of level 3 was generally dry, notwithstanding that he visited the day after “torrential” rains. The following photo (plate 30 of Robery 1) is representative of the largest individual areas of ponding on level 3:

[144] Prof Robery noted that level 3 showed isolated instances of ponding over the new Decseal membrane surface close to the valley gully, but his "overall impression was of a deck that has good gradient falls from high points to valleys that would encourage rapid
